# A FIRE ANALYSIS TOOL REVISITED

## ACOUSTIC SOOT AGGLOMERATION IN RESIDENTIAL SMOKE ALARMS

**Interflam 2004**  
10<sup>th</sup> International Engineering  
Conference  
Edinburgh, Scotland  
July 4-7, 2004

**John A. Kennedy & Associates, Inc.  
Fire and Explosion Analysis Experts  
857 Tallevast Road  
Sarasota, Florida 34243**

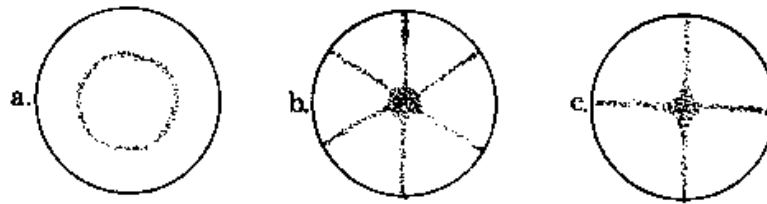
On circular plates, similar in shape to the smoke alarm horn disk, Chladni Figures can be displayed as circumferential circles centered at the center of the flat disk (see a. in Figure 2a), radial arms radiating outward from the center of the disk or combinations (see Figure 2b and c)

Figure 2 - Examples of Circumferential (circular) and radial Chladni figures

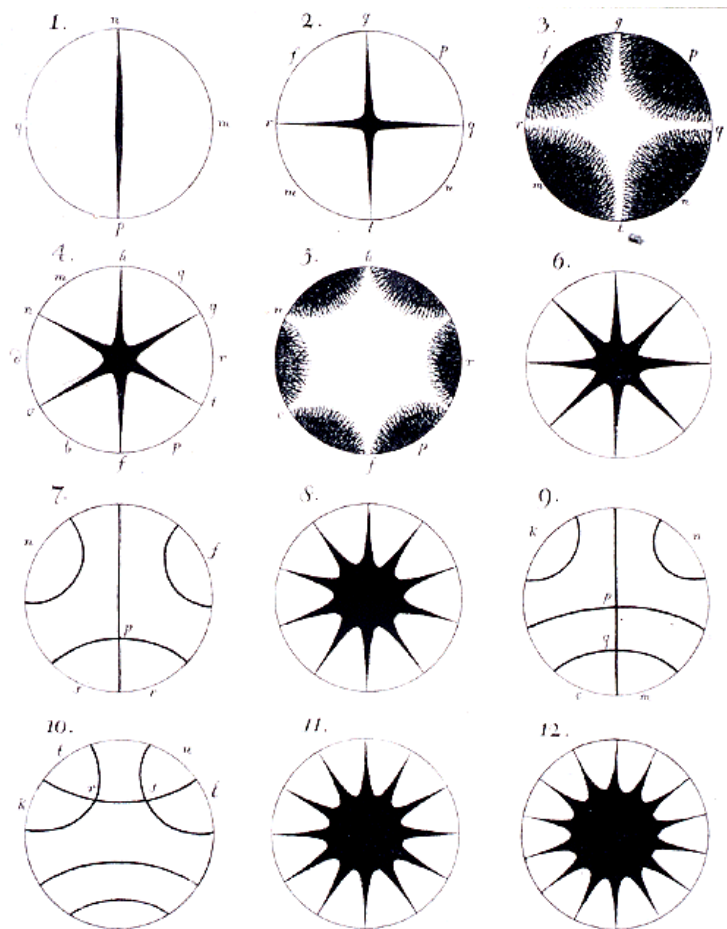
and variations of both including certain “starburst” type shapes (see Figure 3, nos. 4, 6, 8, 11 and 12).

Figure 3 – Additional Chladni Figures  
(from Chladni’s original text).<sup>11,12</sup>

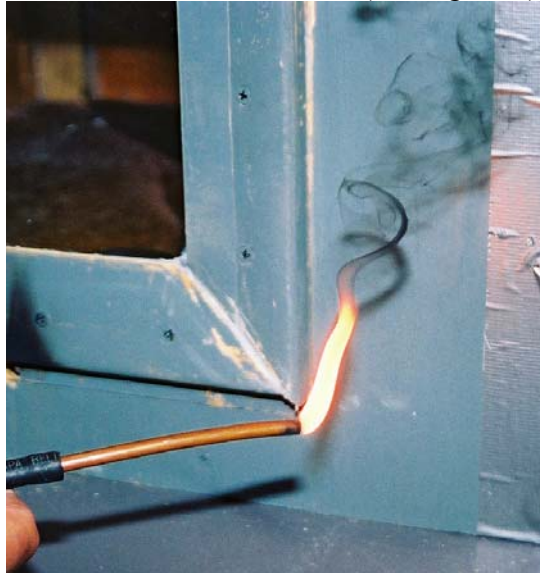
The smoke source was an ~2” laminar gas flame of MAPP Gas ( $C_3H_4$ ) (mixture of 56.0% Propane and 44.0% methylacetylene-propadiene) from a ¼” diameter copper tube burner. The ~2” MAPP Gas laminar flame from a ¼” diameter copper tube burner produces an extremely sooty black smoke which is primary carbon soot in composition. The smoke source is inserted into a hole in the lower center of the chamber front wall beneath the viewing window and extends into the chamber at floor level a distance of 6” (see Figure 4).

**Figure 4 – Smoke Source, 2” laminar MAPP Gas flame**

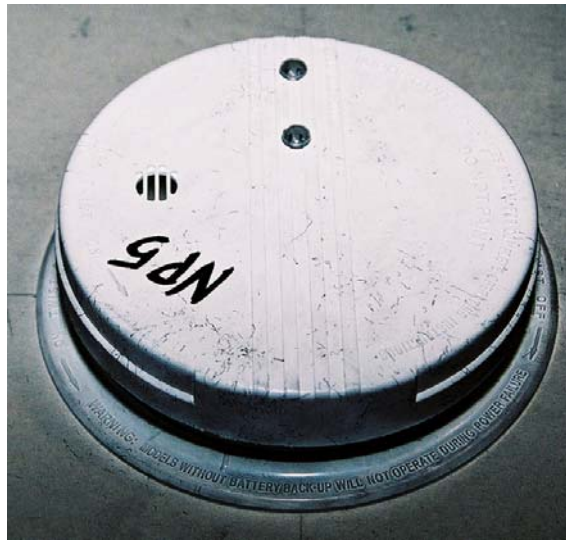
External agglomeration will appear in the cover grillwork of properly operating smoke alarms, particularly in the areas of horn chamber sound outlets (see Figures 10a and 10b and Figure 11).

**Figure 11 – Non-powered Kidde Smoke Alarm without Acoustic Soot Agglomeration on the sound exit grillwork**

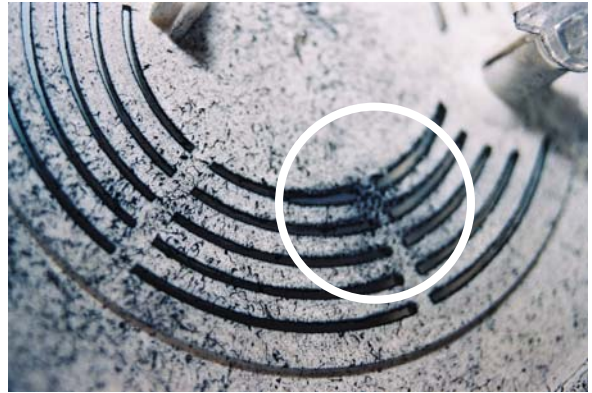
Internal Agglomeration will appear on various internal parts of a properly operating smoke alarm, particularly the sound exit openings of horn enclosures, but also frequently on such other parts as electrical components, circuit boards, and the inside surfaces of the cover grillwork close to the horn disks or horn enclosures (see Figures 12a. and 12b.).

**Figures 12a. and b. - Acoustic Soot Agglomeration on the interior surface of the smoke alarm case directly over the horn compartment central sound exit opening**

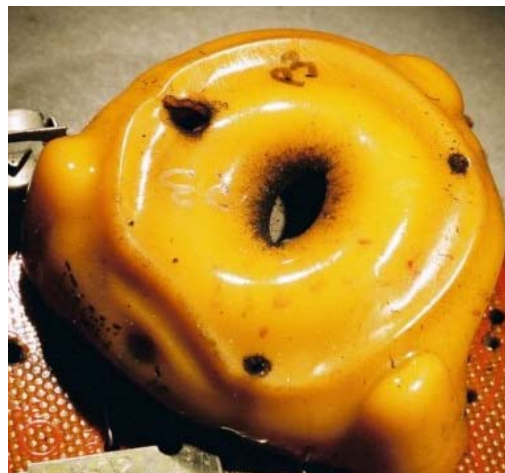
Through heating to temperatures exceeding the approximate temperature at which smoke alarm falldown occurs, 283° F. (139° C), soot deposit patterns persistence occurs as long as the subject smoke alarm is not completely destroyed by subsequent burning.

**Figures 13 a. and b. – Patterns Persistence**  
**Soot agglomeration on a horn enclosure central sound exit opening before (left)**  
**and After (right) heating to 433° F. (223° C) for thirty minutes**

In a second single specific bench test, a previously smoke tested smoke alarm, (P3) bearing acoustic soot agglomeration was subjected to 30 minutes of heating to a temperature of 433° F. (223 C) in a lab furnace. After air cooling the resultant softened and re-solidified plastic of the outer cover and the horn enclosure were examined to see if the deposited Acoustic Soot Agglomerations persisted.

*Patterns Persistence* – To test patterns persistence, a previously smoke tested alarm, (P3) bearing acoustic soot agglomeration was subjected to 30 minutes of heating in a lab furnace to a temperature of 433° F. (223° C). After air-cooling the resultant softened and re-solidified plastic of the outer cover and the horn enclosure were examined to see if the deposited Acoustic Soot Agglomerations persisted. Patterns persistence was evident.
